DEPARTMENT OF TRANSPORTATION

Contract #: 04-0120F4Cty: SF/ALA Rte: 80 PM: 13.2/13.9File #: 1.28**WELDING INSPECTION REPORT****Resident Engineer:** Pursell, Gary**Address:** 333 Burma Road**City:** Oakland, CA 94607**Report No:** WIR-014304**Date Inspected:** 19-May-2010**Project Name:** SAS Superstructure**OSM Arrival Time:** 700**Prime Contractor:** American Bridge/Fluor Enterprises, a JV**OSM Departure Time:** 1530**Contractor:** American Bridge/Fluor Enterprises, a JV**Location:** Job Site**CWI Name:** See Below**CWI Present:** Yes No**Inspected CWI report:** Yes No N/A**Rod Oven in Use:** Yes No N/A**Electrode to specification:** Yes No N/A**Weld Procedures Followed:** Yes No N/A**Qualified Welders:** Yes No N/A**Verified Joint Fit-up:** Yes No N/A**Approved Drawings:** Yes No N/A**Approved WPS:** Yes No N/A**Delayed / Cancelled:** Yes No N/A**Bridge No:** 34-0006**Component:** Orthotropic Box Girders (OBG)**Summary of Items Observed:**

Field Splice 3E/4E Face C (Inside) Repairs

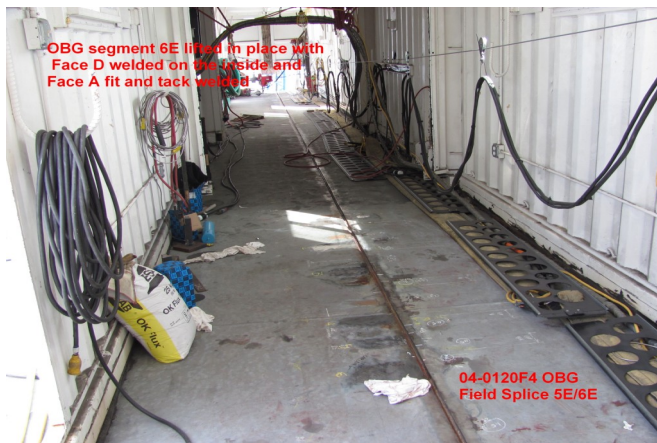
The QA inspector periodically observed ABF welding personnel performing grinding and blending of the areas in which temporary attachments were welded to the deck plate for jacking purposes the previous day. The work progressed throughout a portion of the shift, was completed and QC personnel was noted to perform magnetic particle testing and ultrasonic testing in the areas affected. No rejectable indication were noted at the time of review and the QA inspector did not observed any further work at this location for the remainder of the QA inspectors shift. See digital photos in the body of this report for general information.
